Conservation and Restoration of E & F Group of Temples  
My Son Sanctuary, Da Nang City, Vietnam  
1st Working Session Feb 2025 to Jan 2026

PHOTOBOOK ON  
ANNUAL PROGRESS REPORT OF EXECUTED PROJECT WORKS OF  
CONSERVATION & RESTORATION OF THE E & F GROUP OF TEMPLES, MY SON SANCTUARY (WHS), DA NANG CITY, VIETNAM  
1st Working Session Feb 2025 to Jan 2026

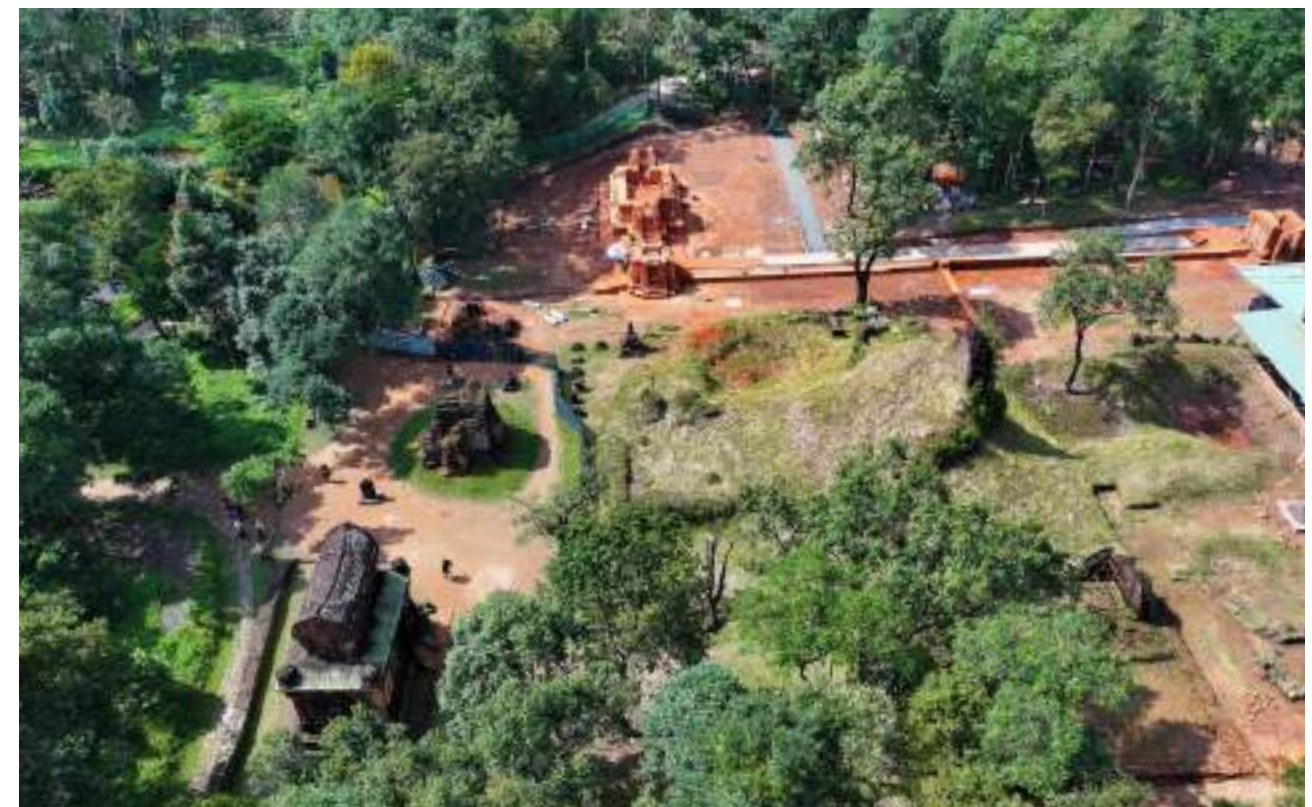
AFTER: Aerial view from east to west, E & F Group of Temples

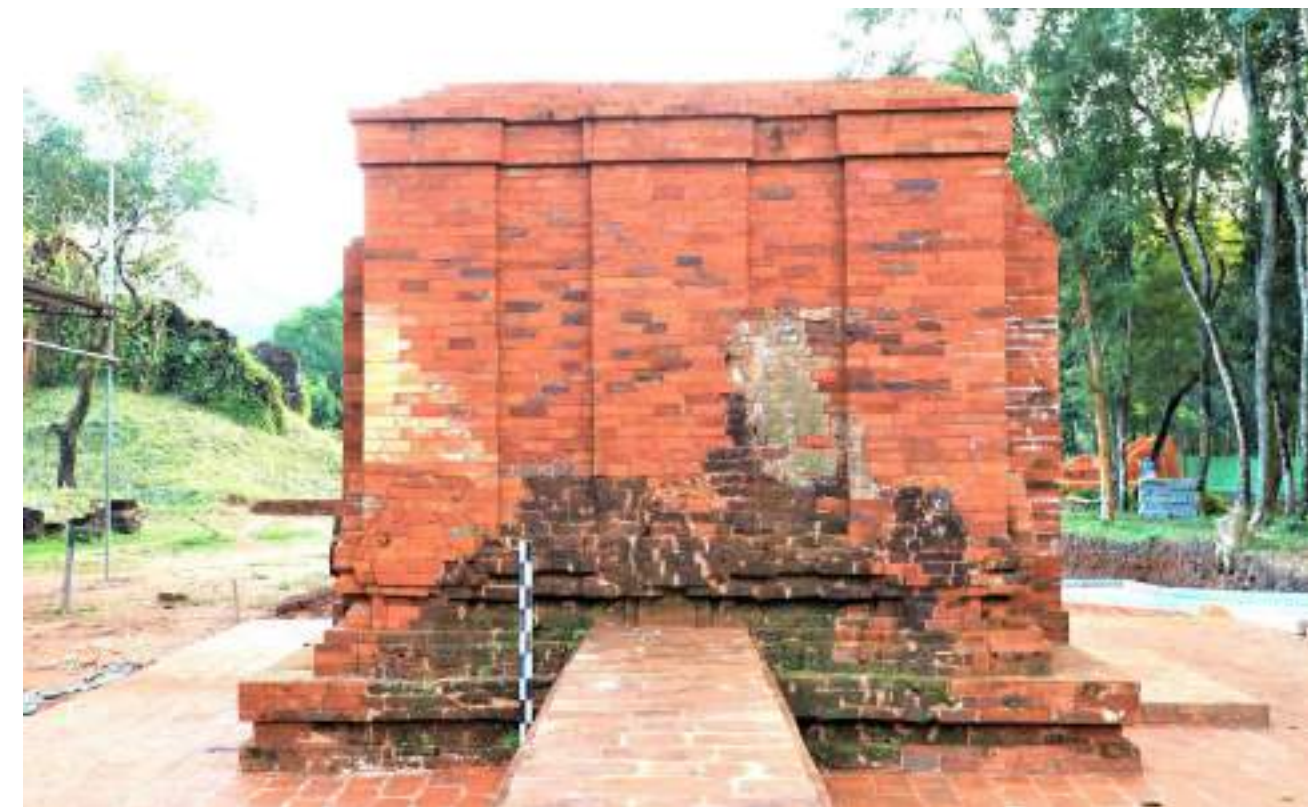
AFTER: Group of temple - F2 - North view

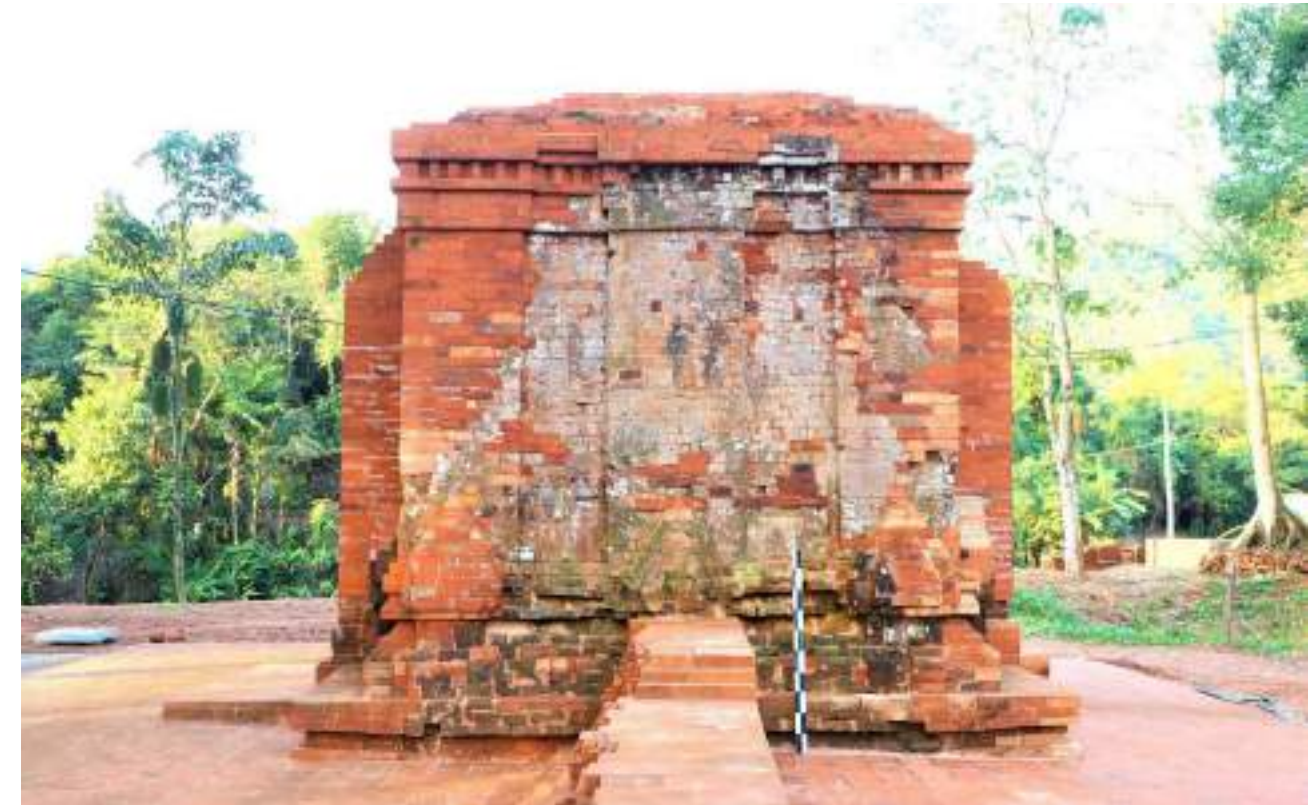
AFTER: Group of Temple - F2 - South view

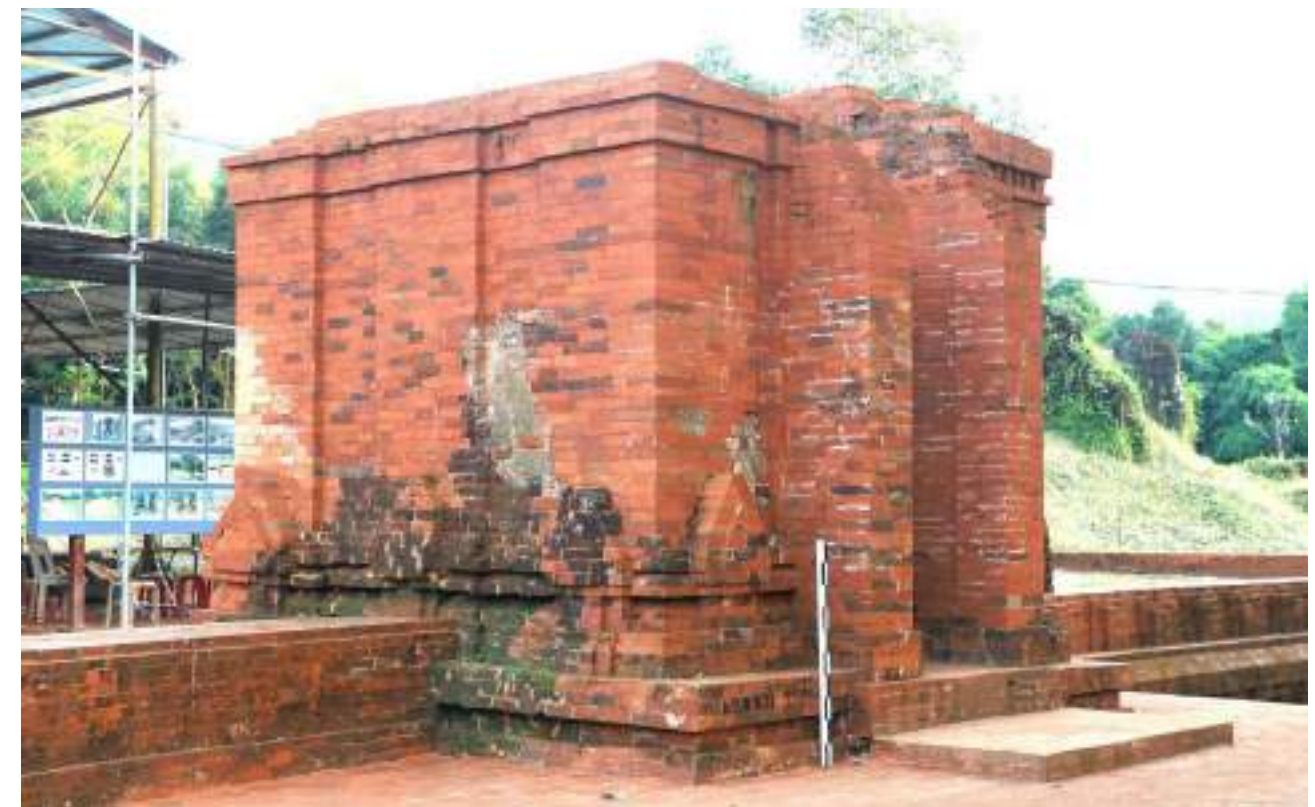
AFTER: Group of Temple - F2 - North-west view

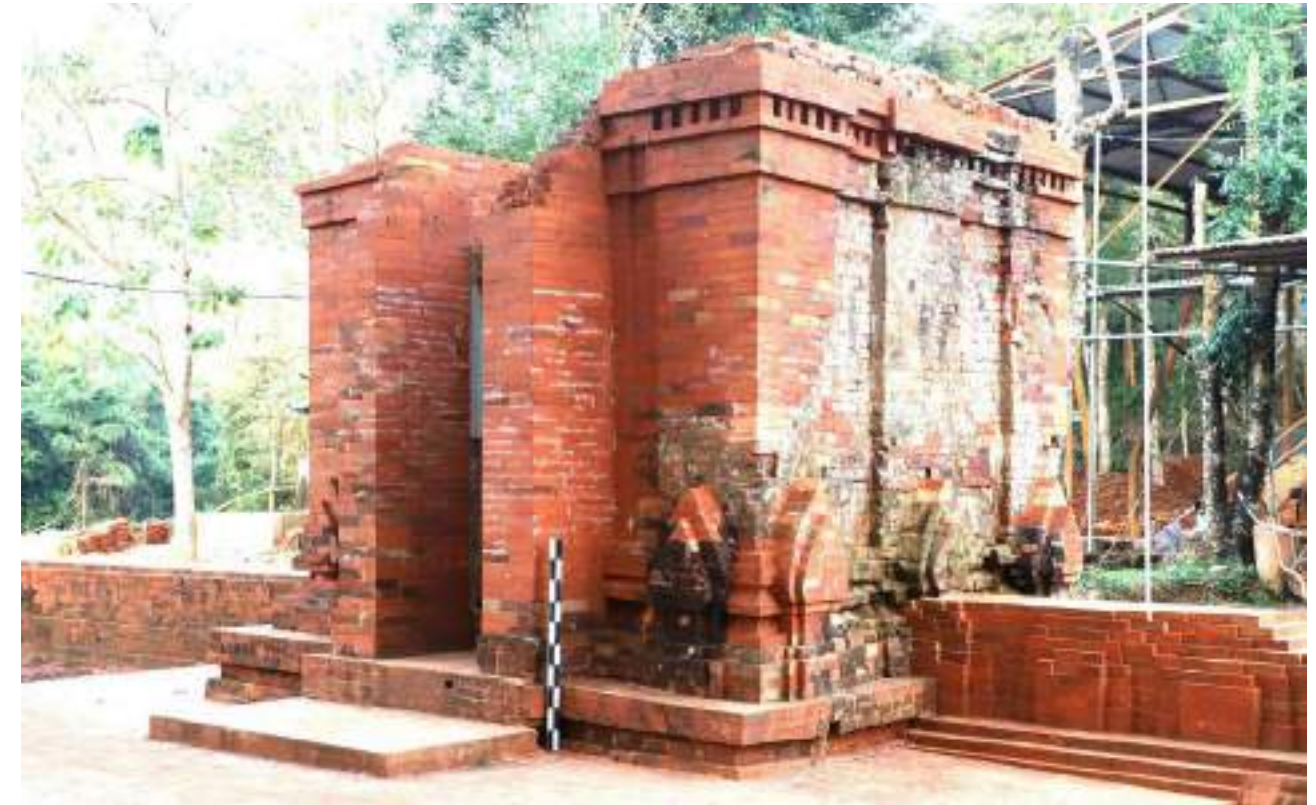
AFTER: Group of Temple - F2 - South-west view

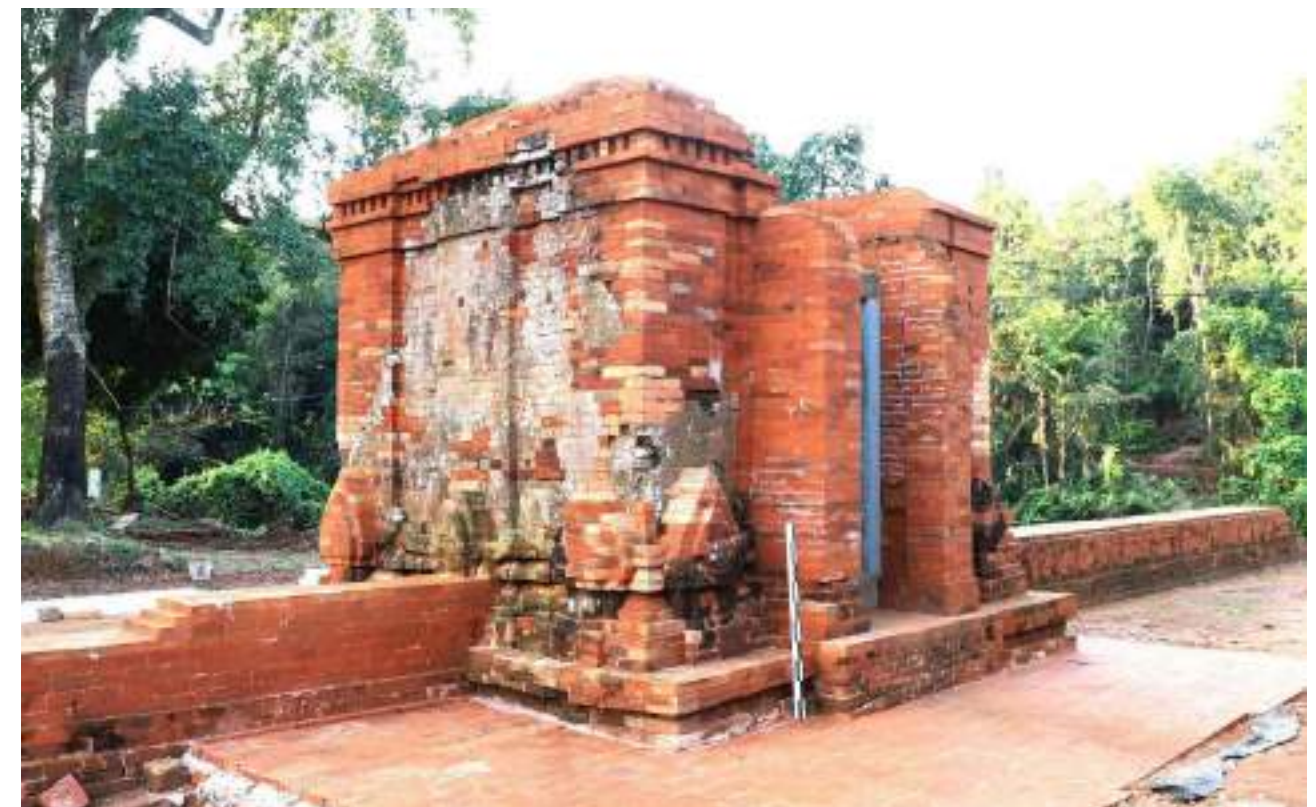
AFTER: Group of Temple - F2 - South-east view

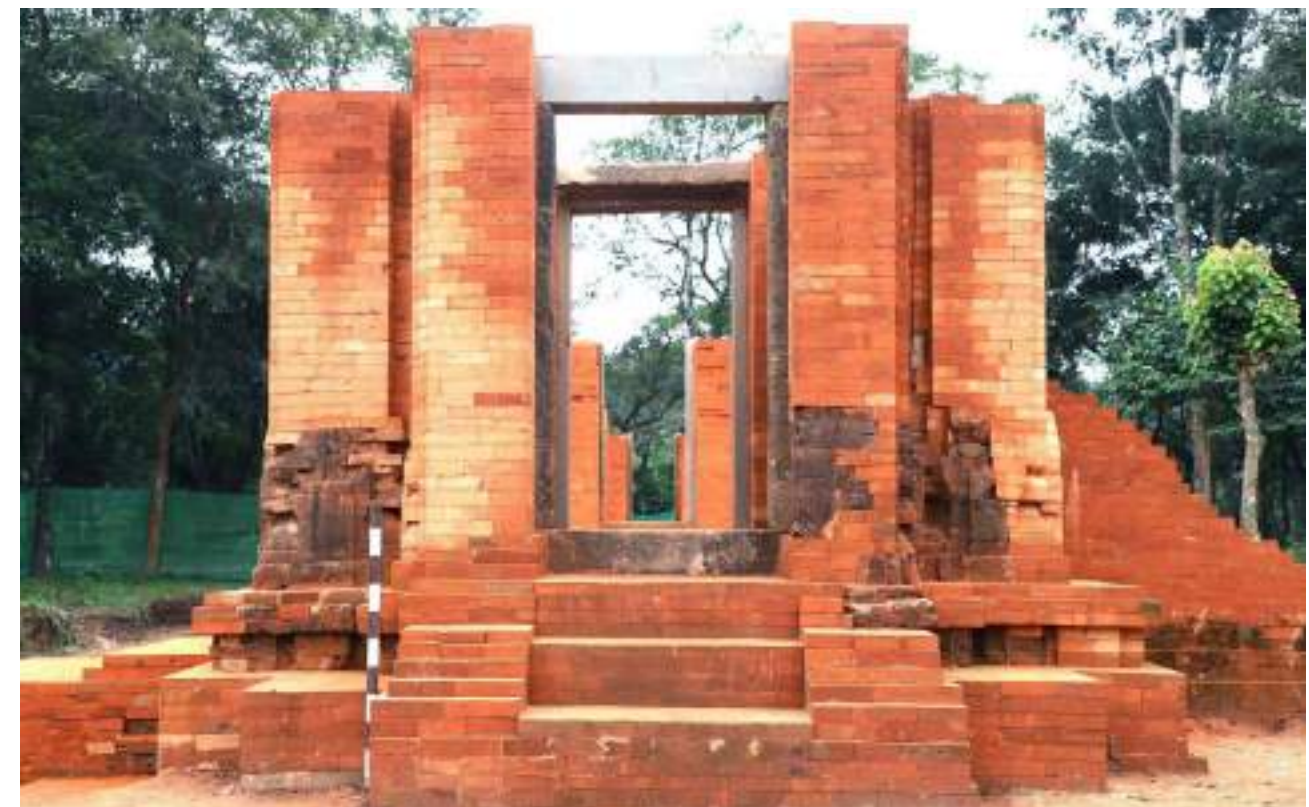
AFTER: Group of Temple - E2 - East view

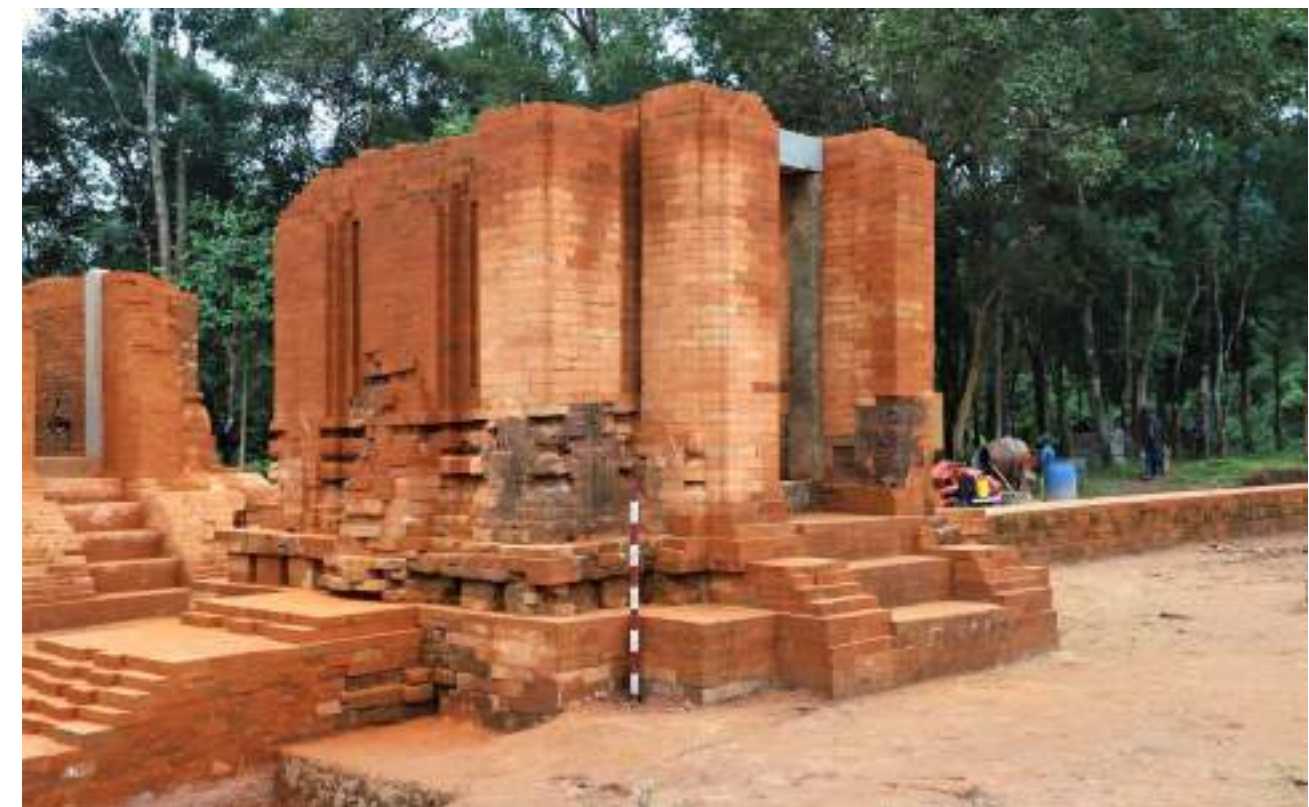
AFTER: Group of Temple - E2 - South-east view

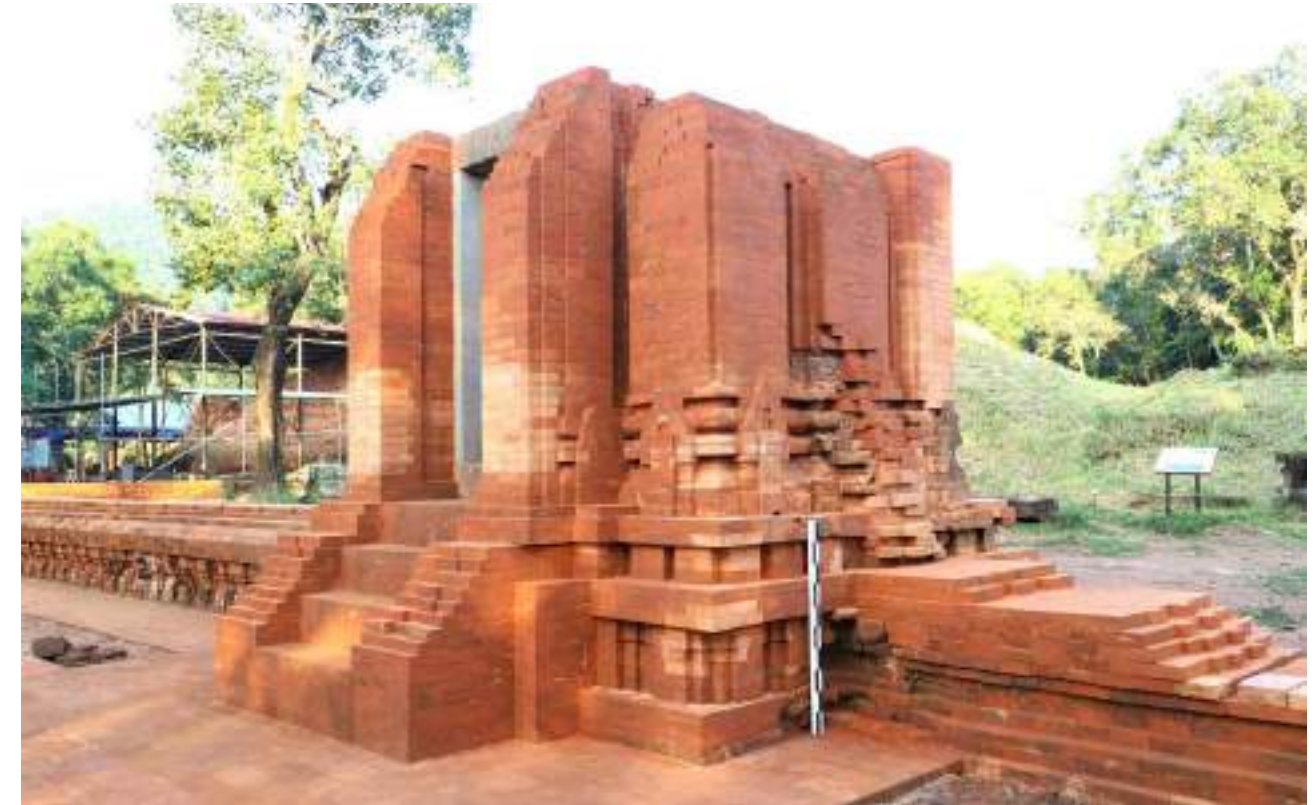
AFTER: Group of Temple - E2 - South-west view

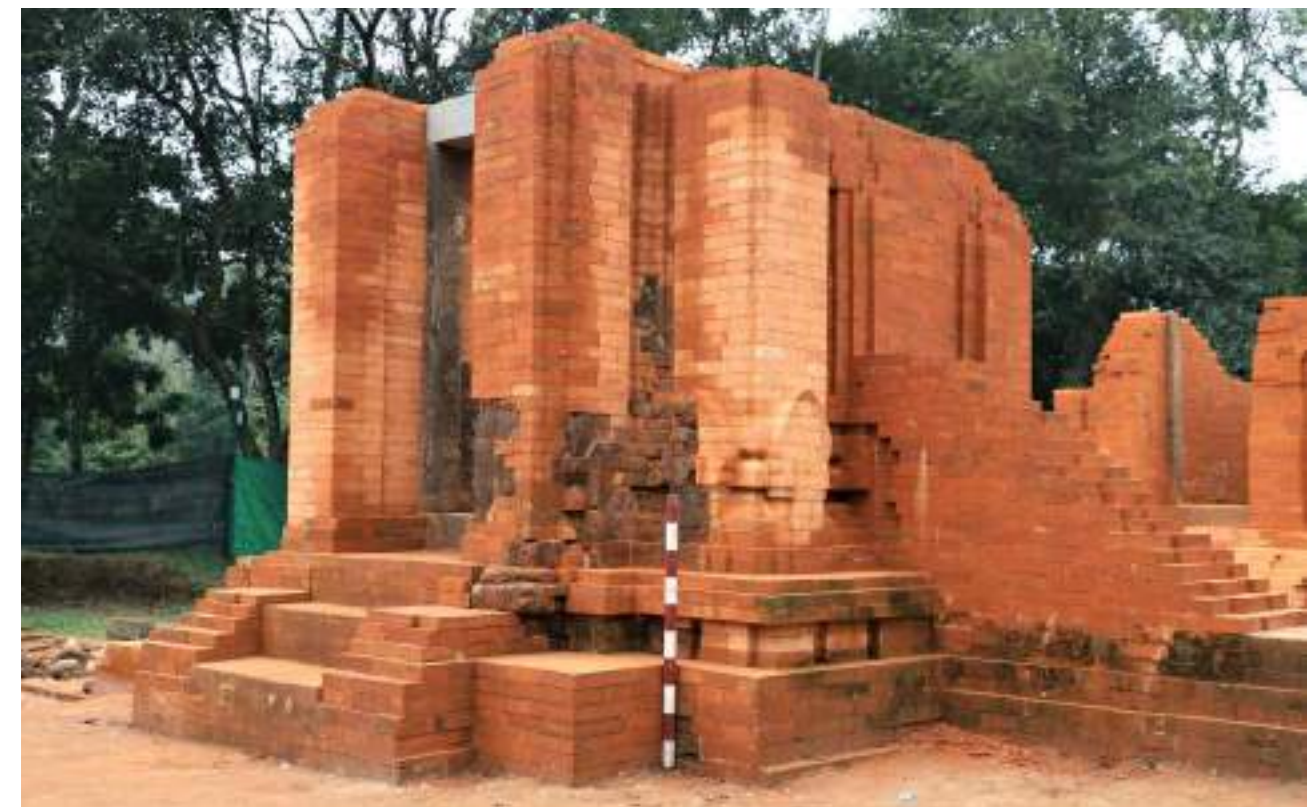
AFTER: Group of Temple - E2 - North-east view

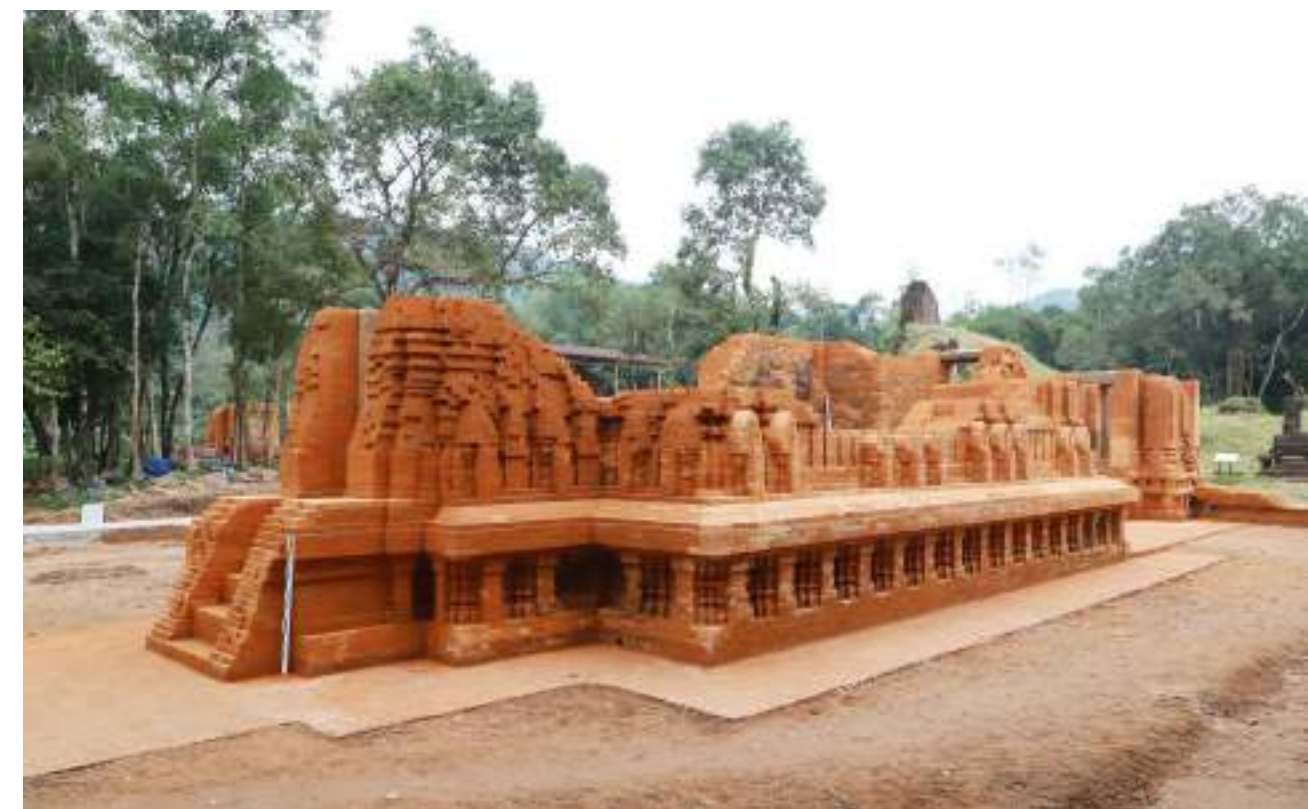
AFTER: Group of temple E3 - South-west view

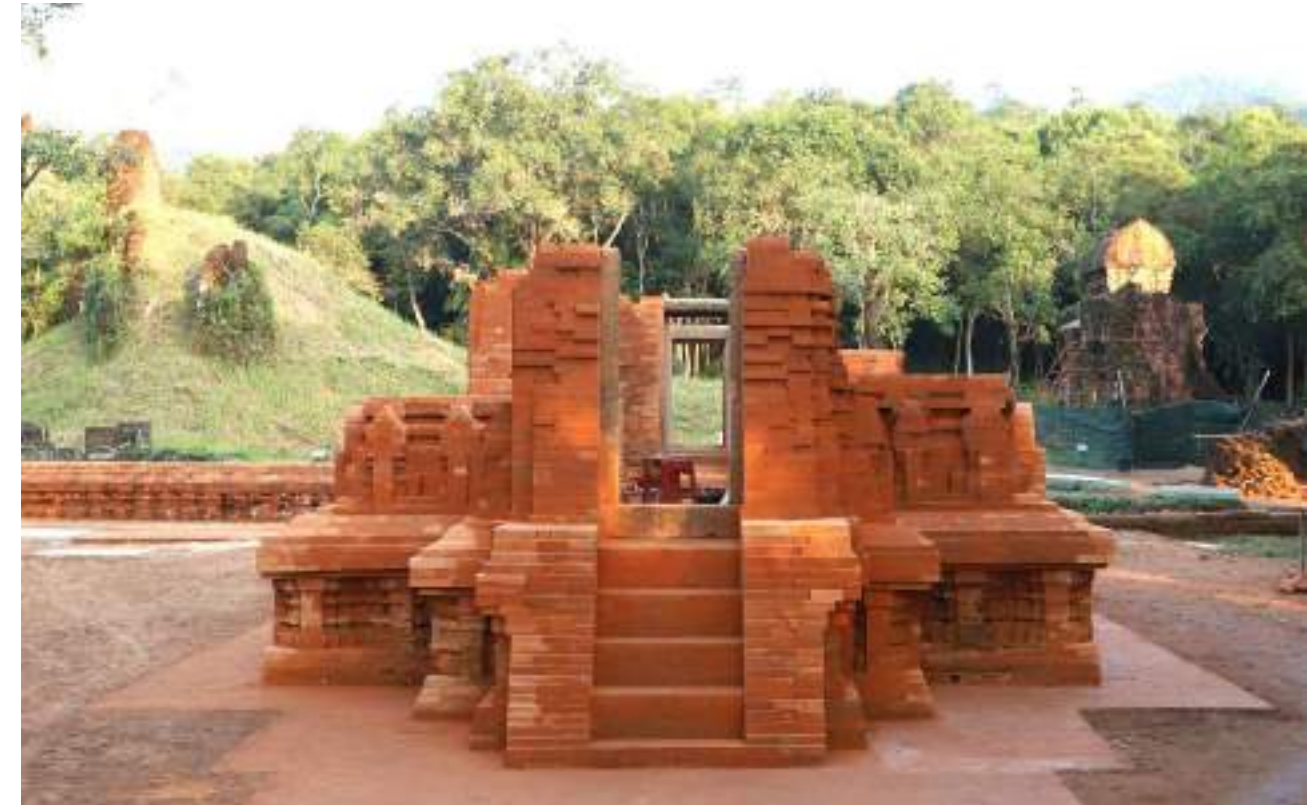
AFTER: Group of temple E3 - West view

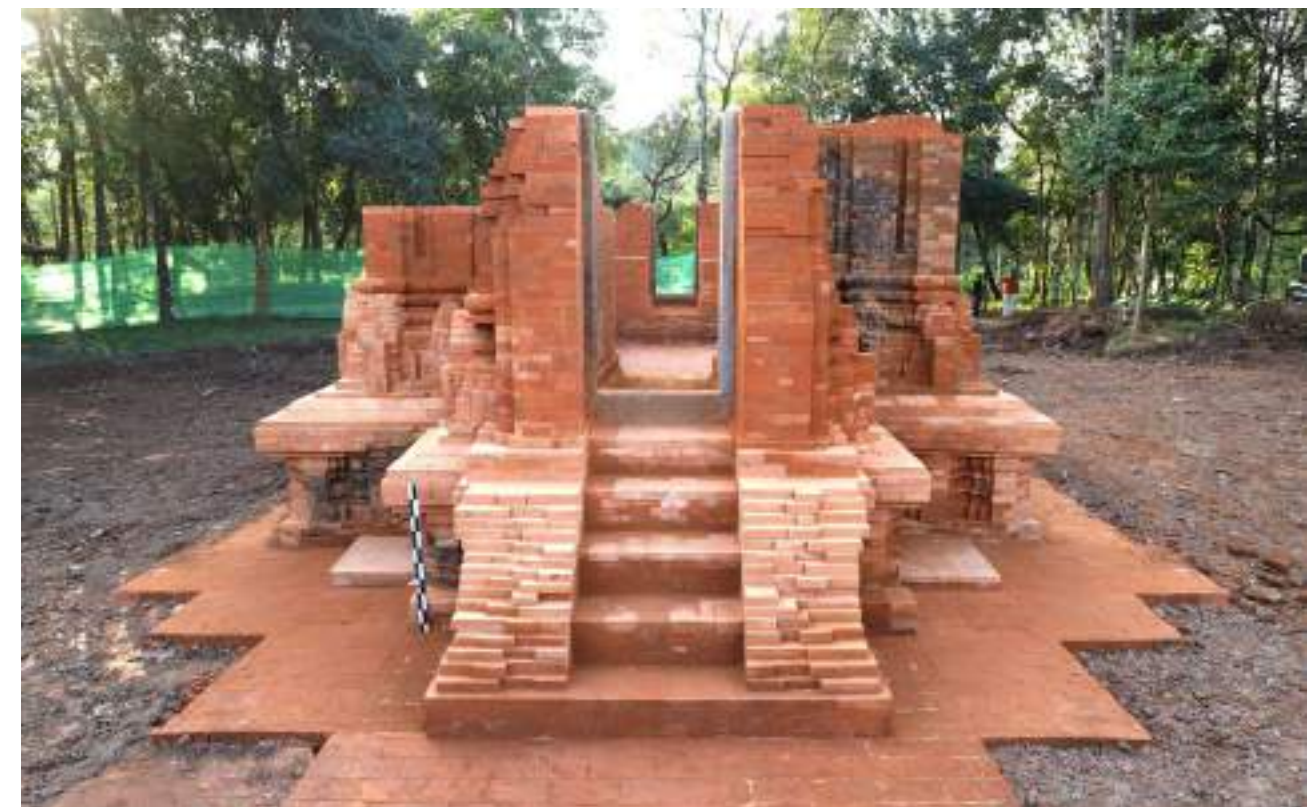
AFTER: Group of temple E3 - East view

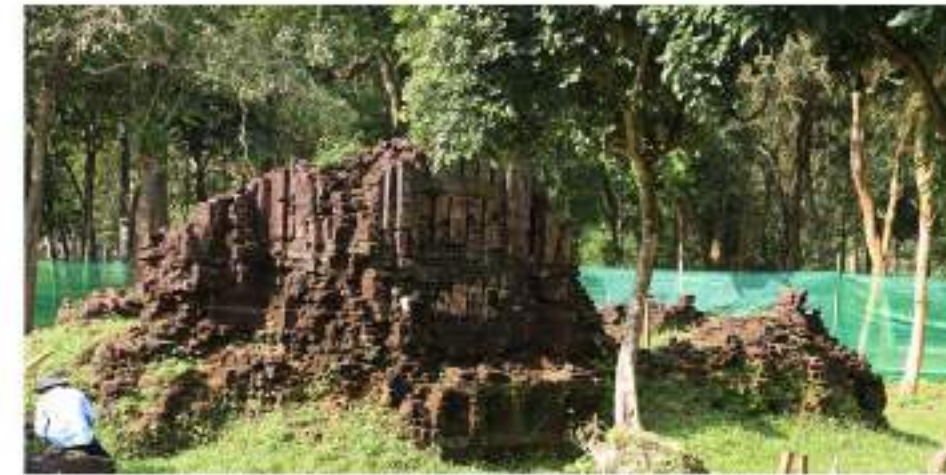
E-Group Before: Condition of structure

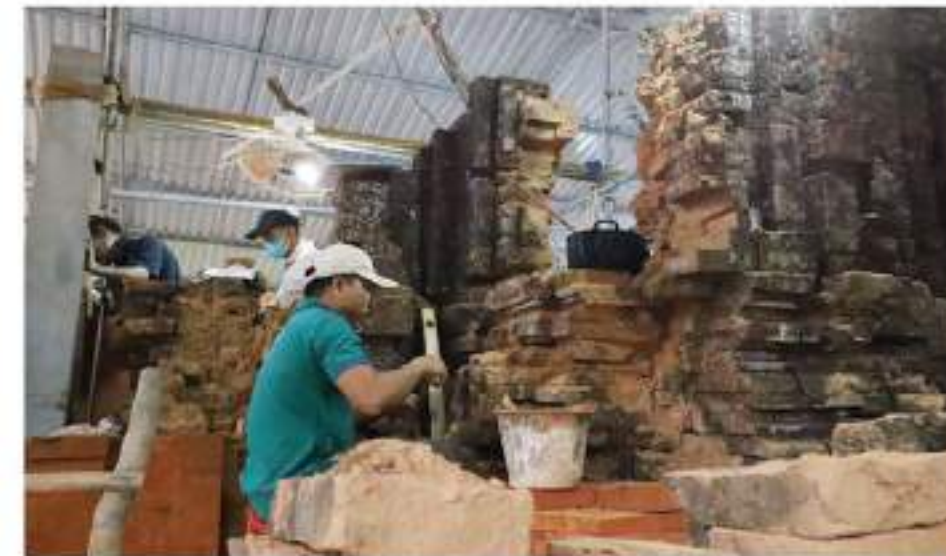
E-Group During: Numbering, dismantling & restoration

Where structural deformations are severe, such as wider cracks, major inclinations, or displaced architectural components, the method of anastylosis will be applied. This process involves dismantling, strengthening, and scientifically reassembling the original components in their original positions, guided by reliable archaeological evidence.

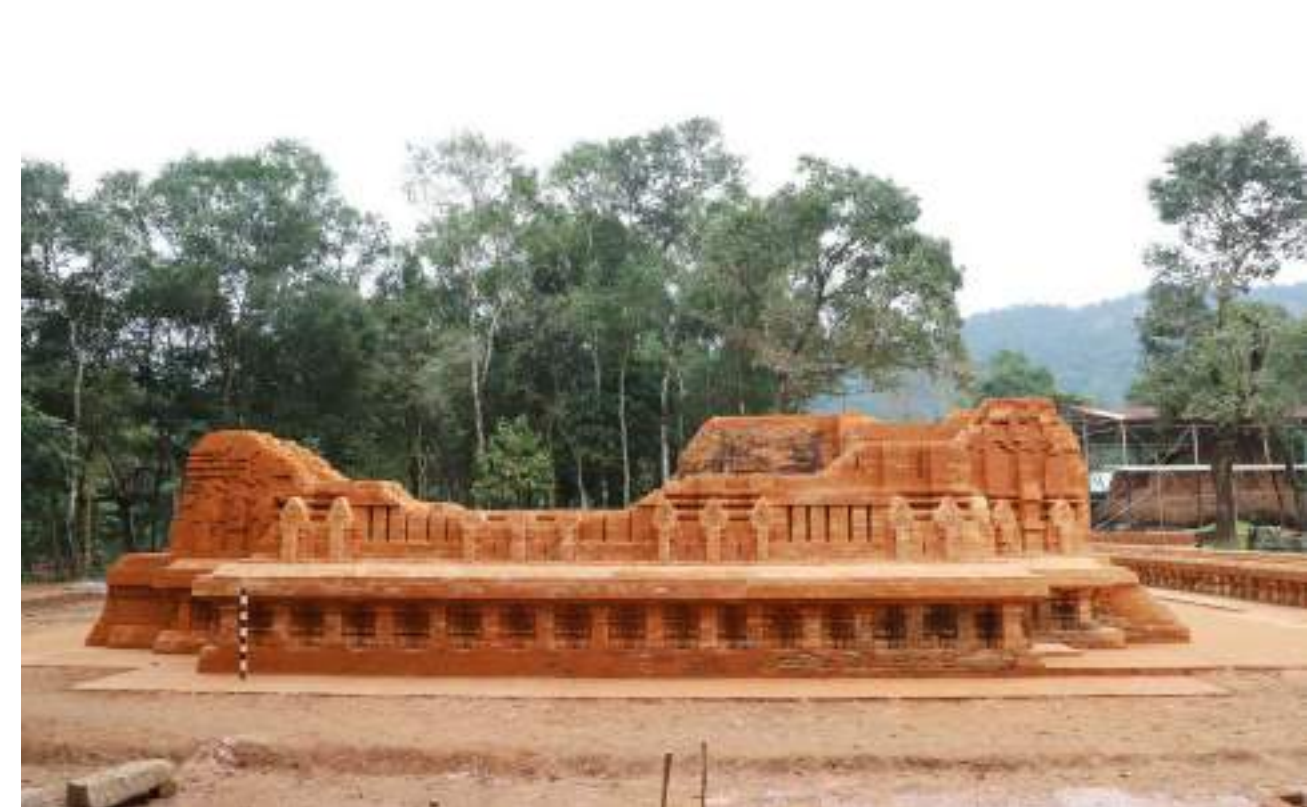
AFTER: Group of temple E3 - South view

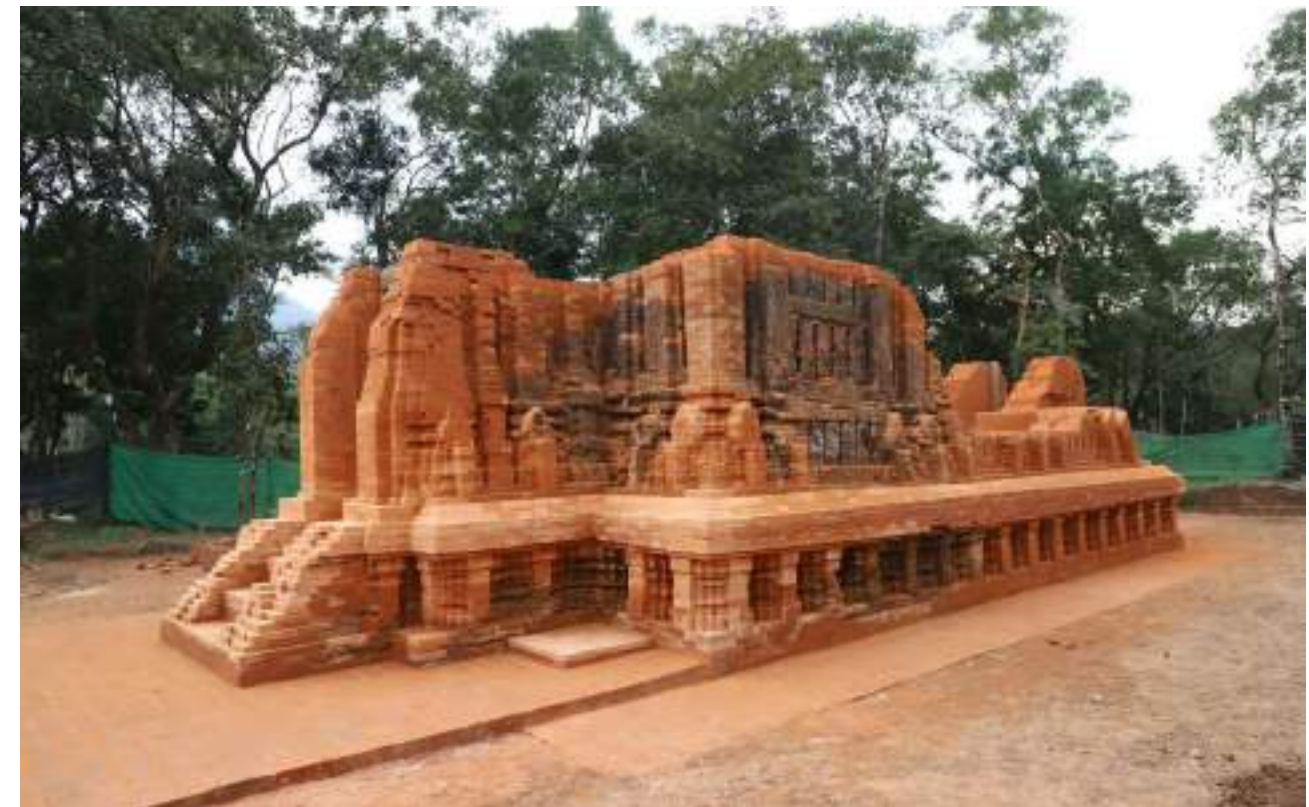
AFTER: Group of temple E3 - North-east view

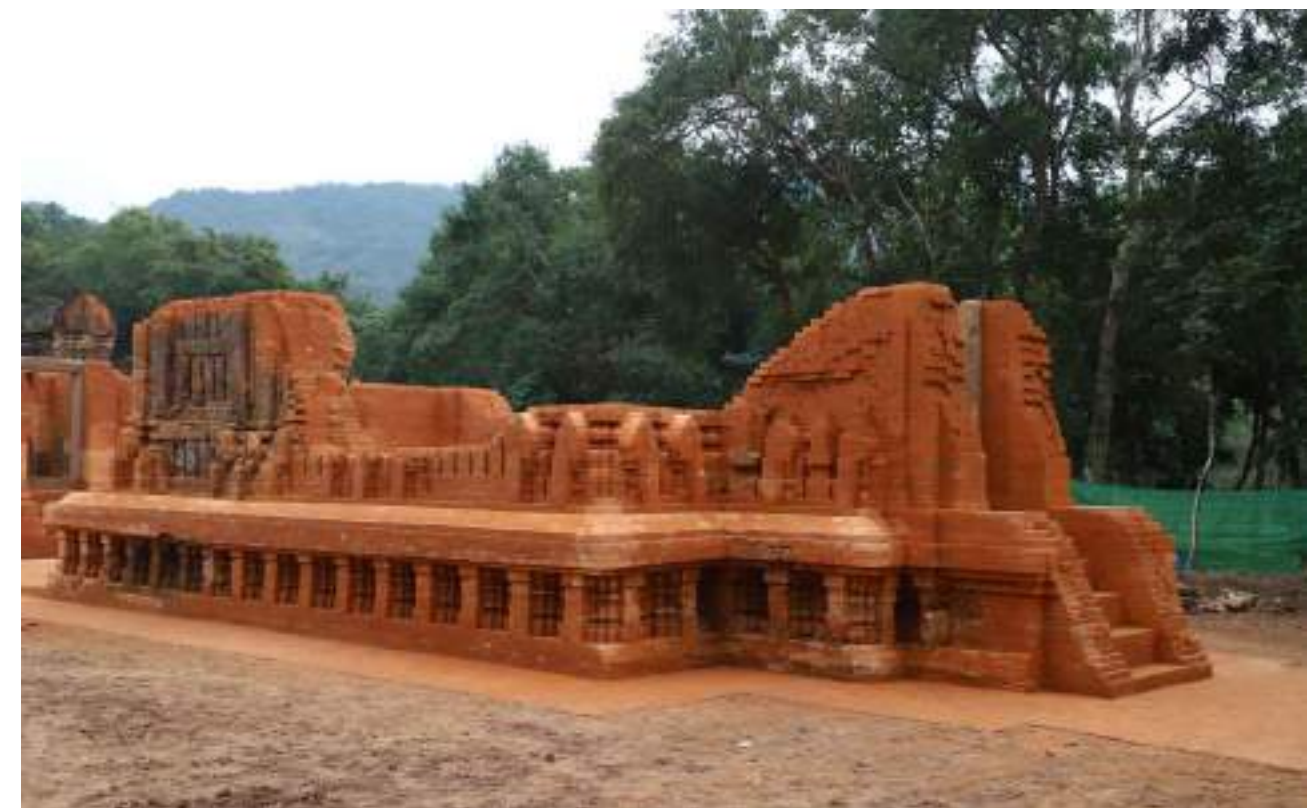
AFTER: Group of temple E3 - North-west view

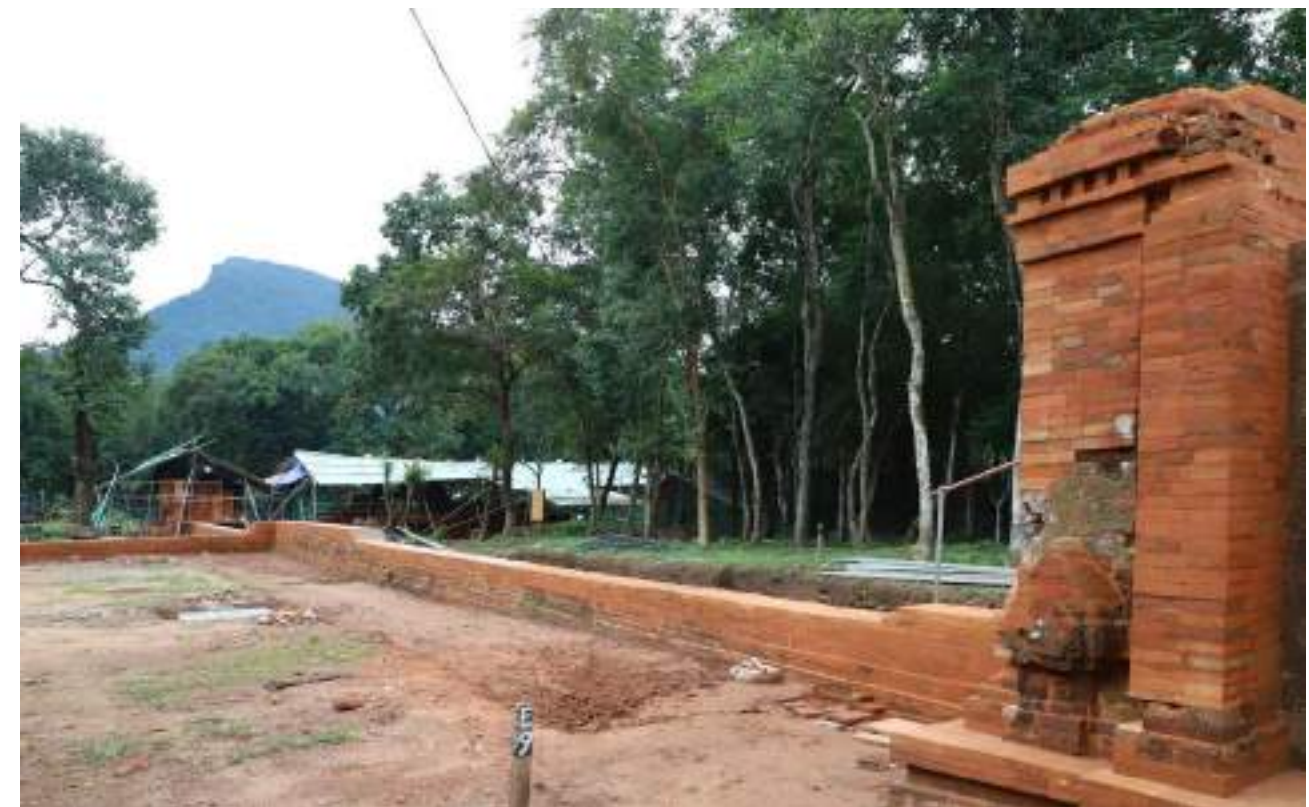
AFTER: Conservation & Restoration of West Enclosure wall

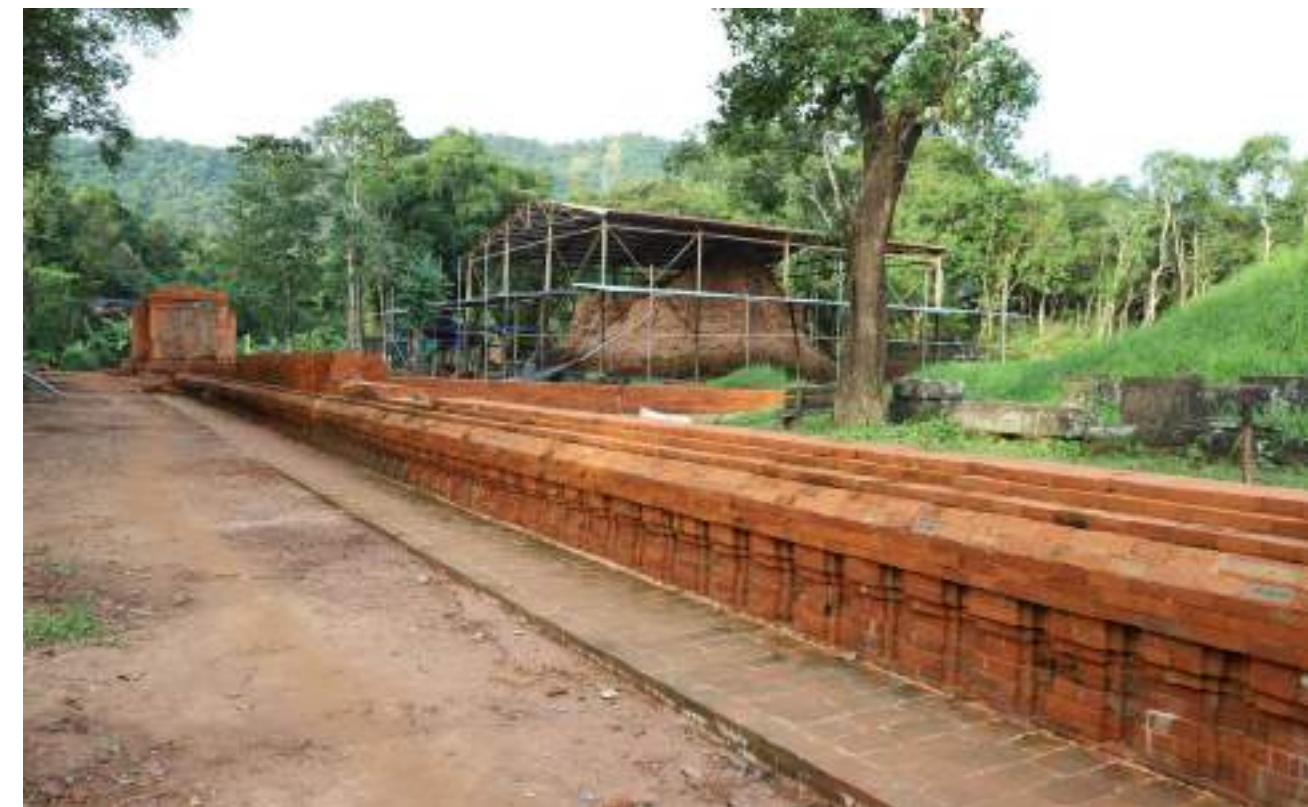
AFTER: Conservation & Restoration of West Enclosure wall

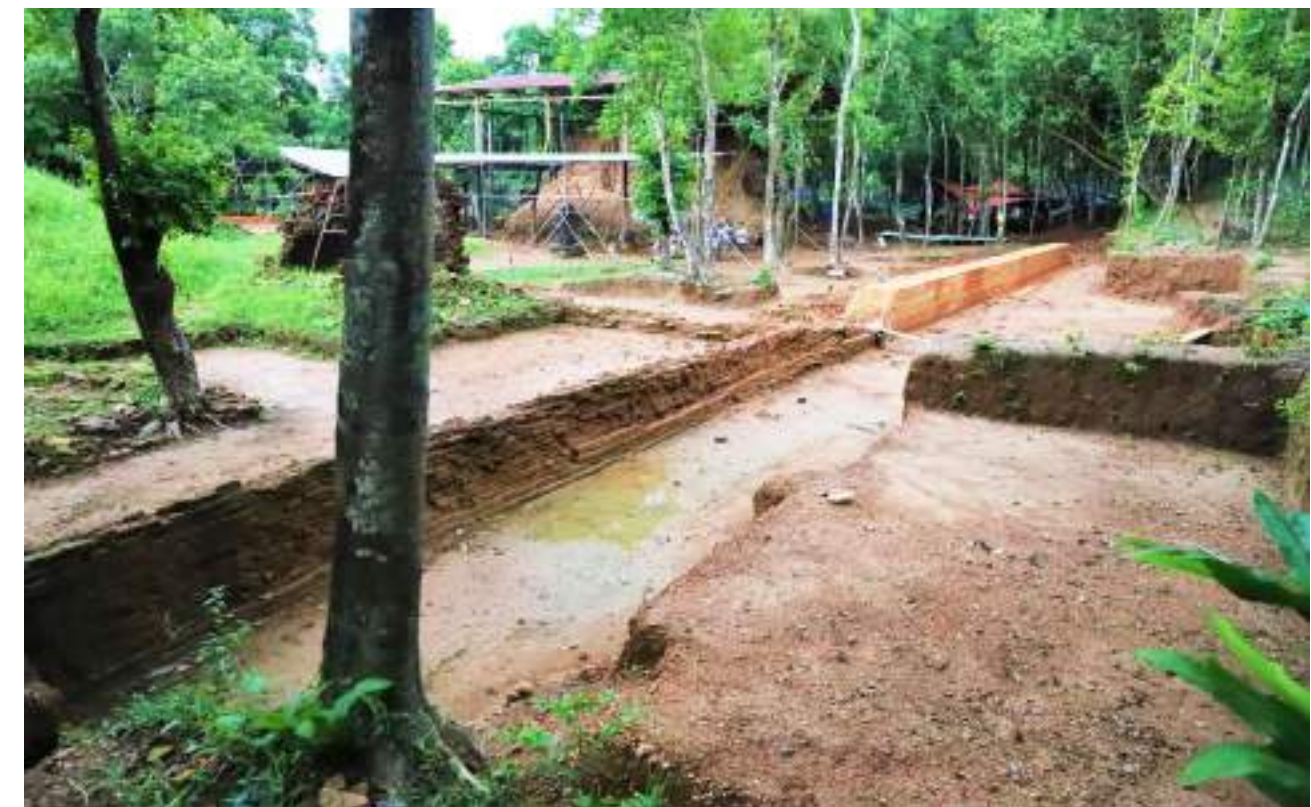
AFTER: Conservation & Restoration of East Enclosure wall

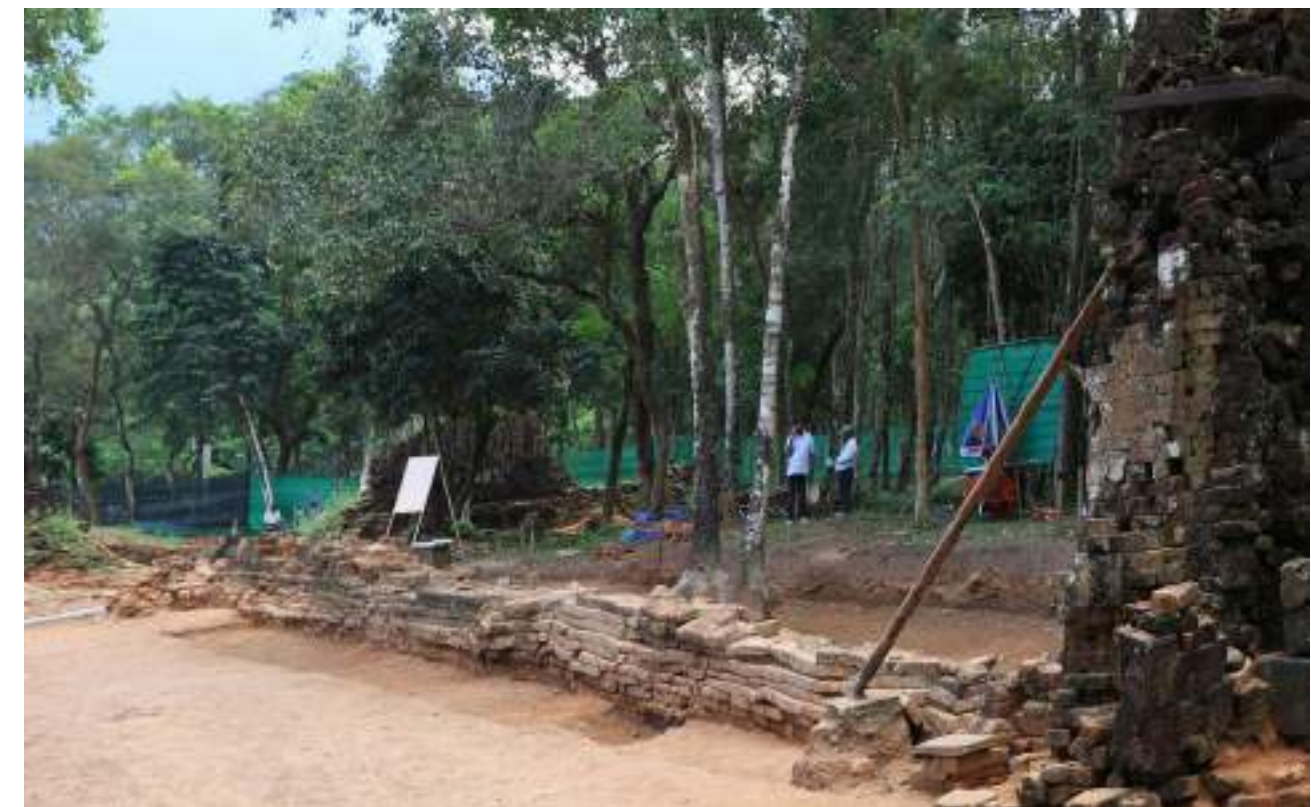
AFTER: Scientific debris clearance

- Debris removal was conducted using standard archaeological procedures:
- Layer-by-layer removal
- Manual tools (trowels, brushes, spades)
- Documentation of each layer (photographs, drawings, soil descriptions)
- Tagging of architectural fragments
- Separate collection of artefacts, if encountered
- Vegetation and root systems were removed carefully to prevent further structural damage.
