Conservation and Restoration of E & F Group of Temples  
My Son Sanctuary, Da Nang City, Vietnam  
1st Working Session Feb 2025 to Jan 2026

PHOTOBOOK ON  
ANNUAL PROGRESS REPORT OF EXECUTED PROJECT WORKS OF  
CONSERVATION & RESTORATION OF THE E & F GROUP OF TEMPLES, MY SON SANCTUARY (WHS), DA NANG CITY, VIETNAM  
1st Working Session Feb 2025 to Jan 2026

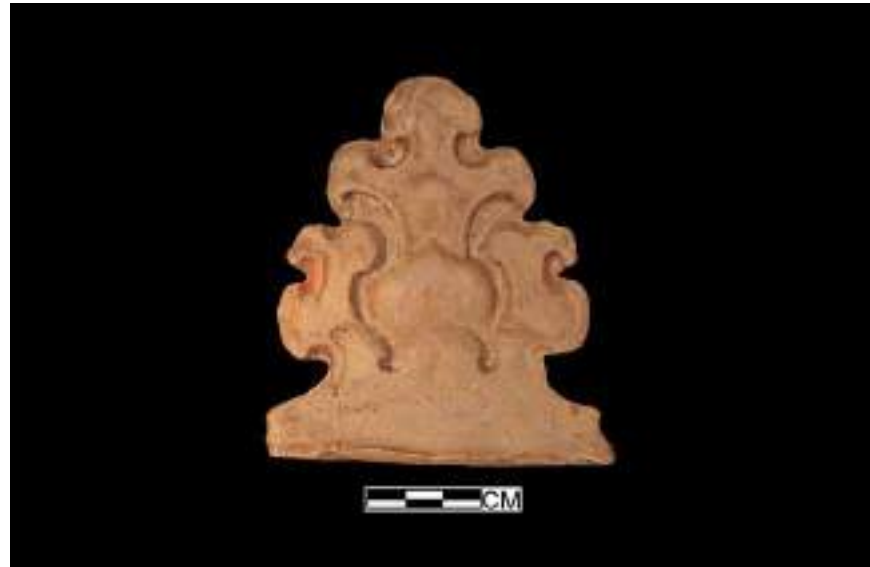
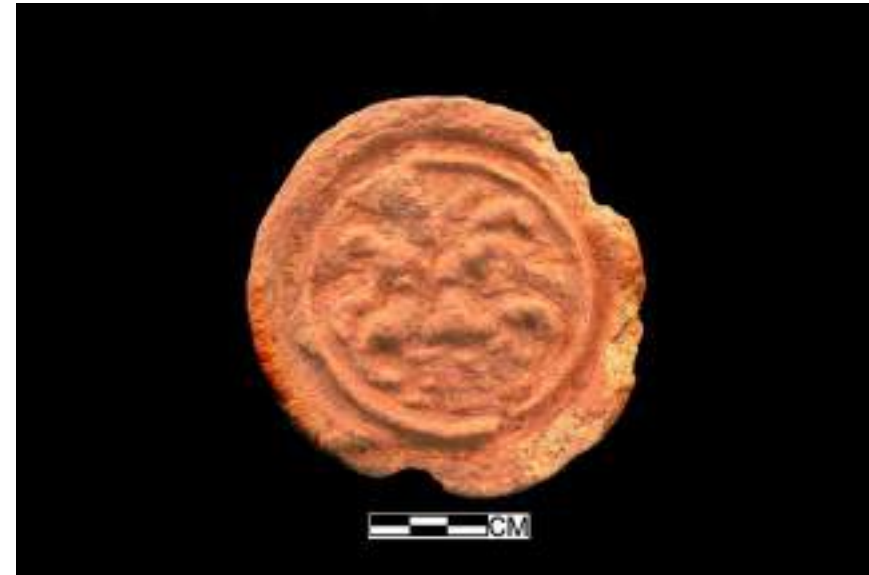
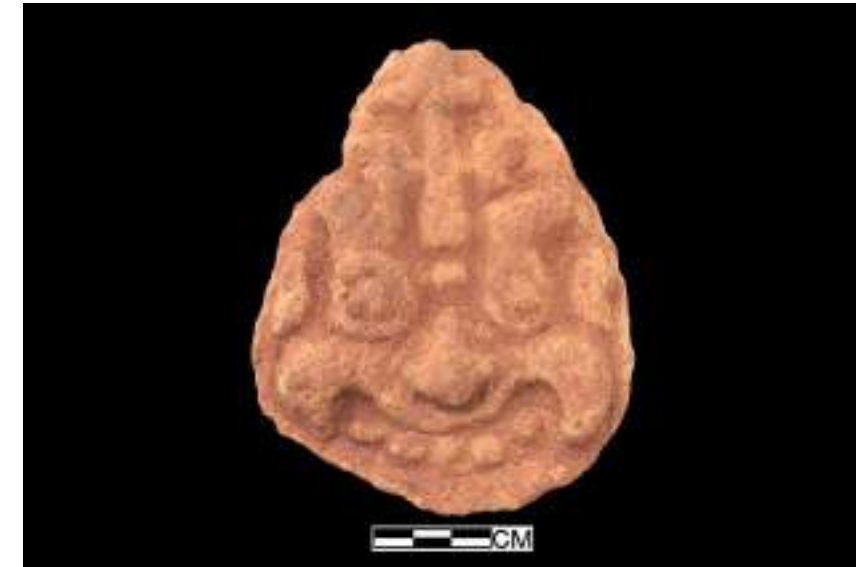
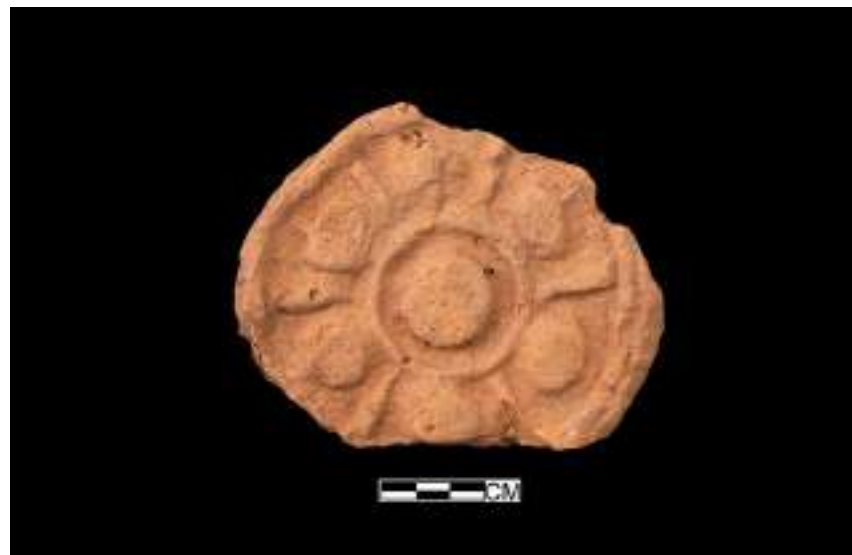
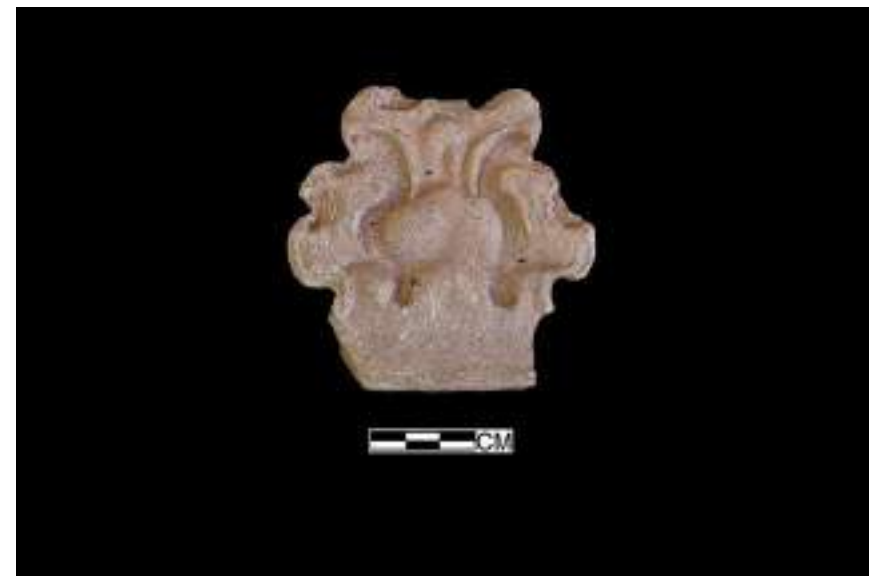
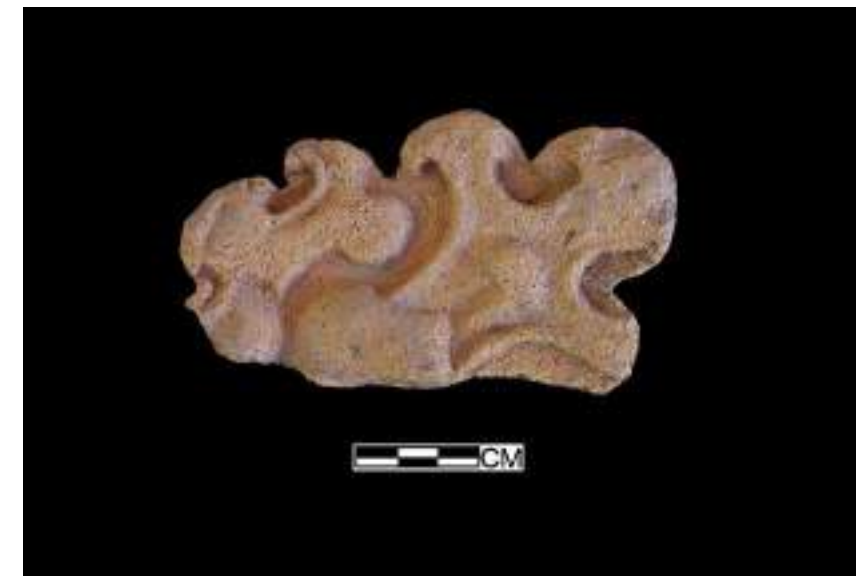
Tile pieces found while debris clearance

During the current season, scientific debris clearance revealed terracotta roof tiles, which, according to the stratigraphy of the trenches, may have been associated with wooden structures that once existed in the complex, but were likely destroyed over time. It is found that additions & alterations of some of the structures/Shiv Linga, etc., in the past were carried out, which were observed.

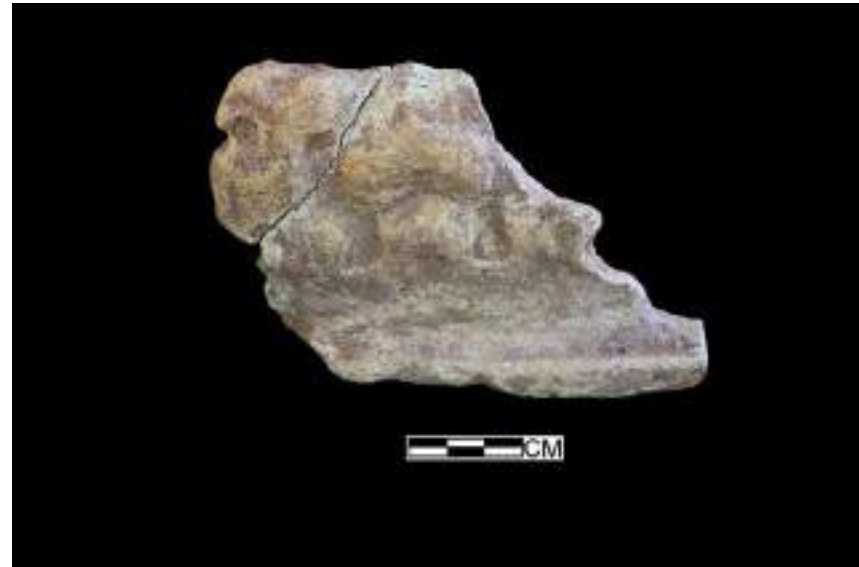
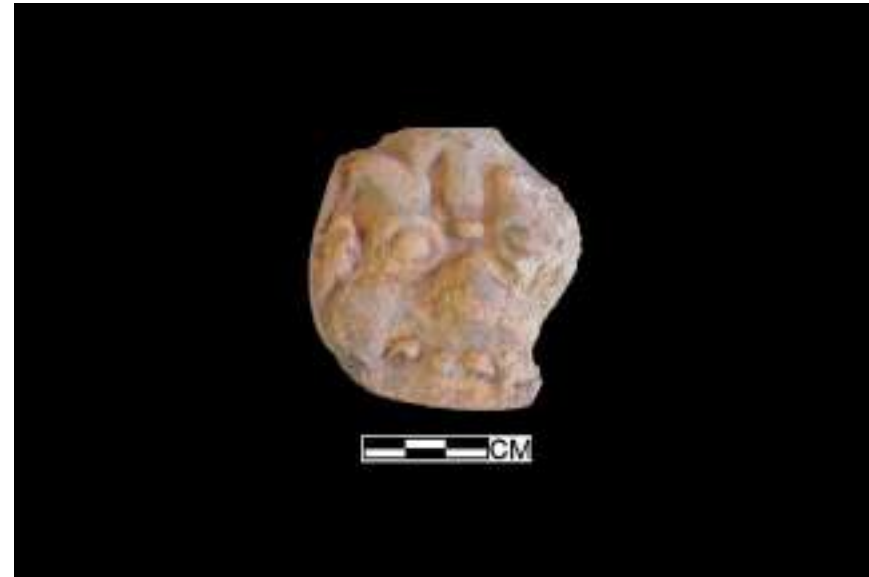
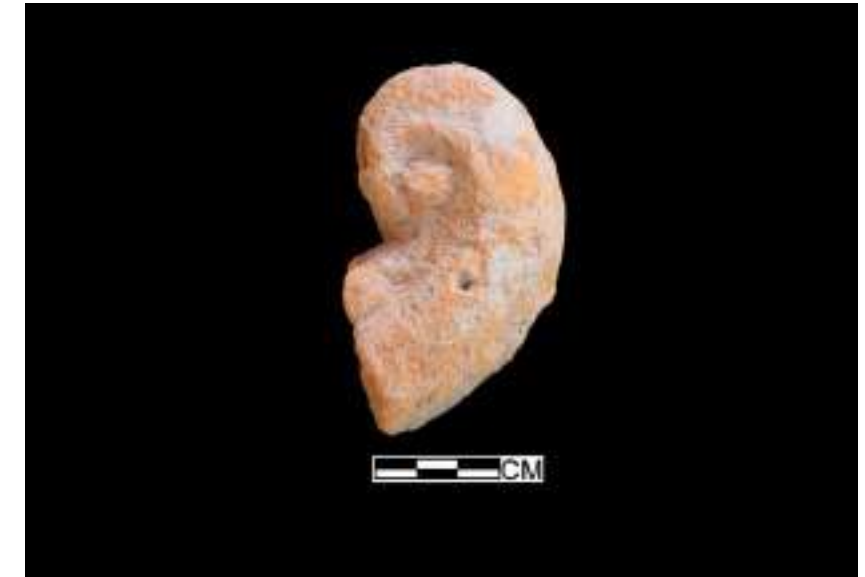
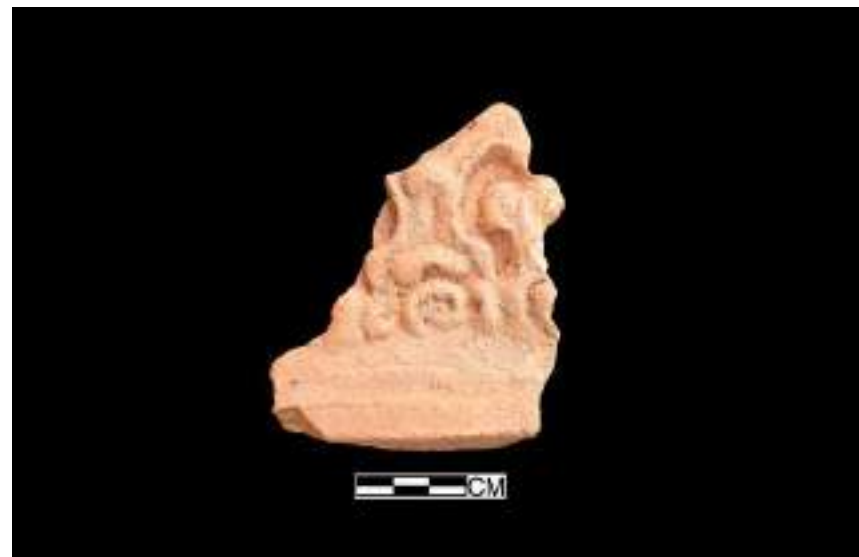
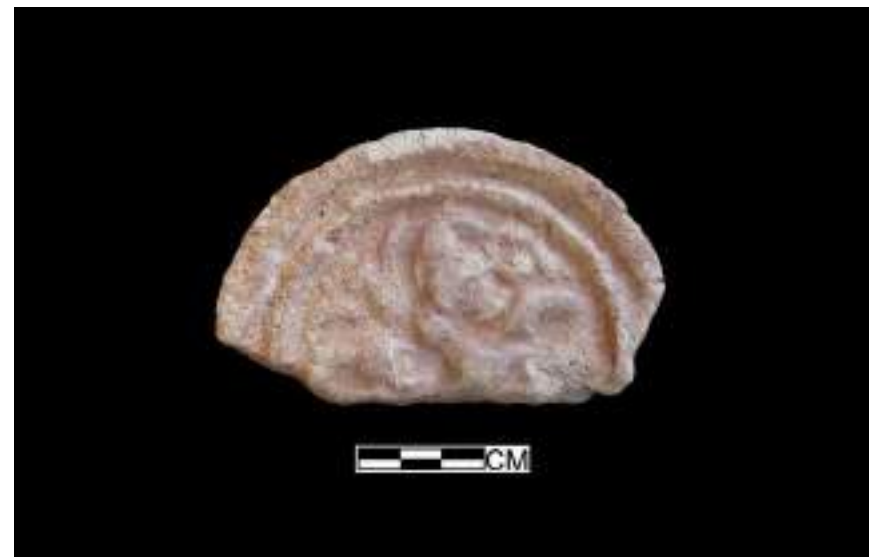
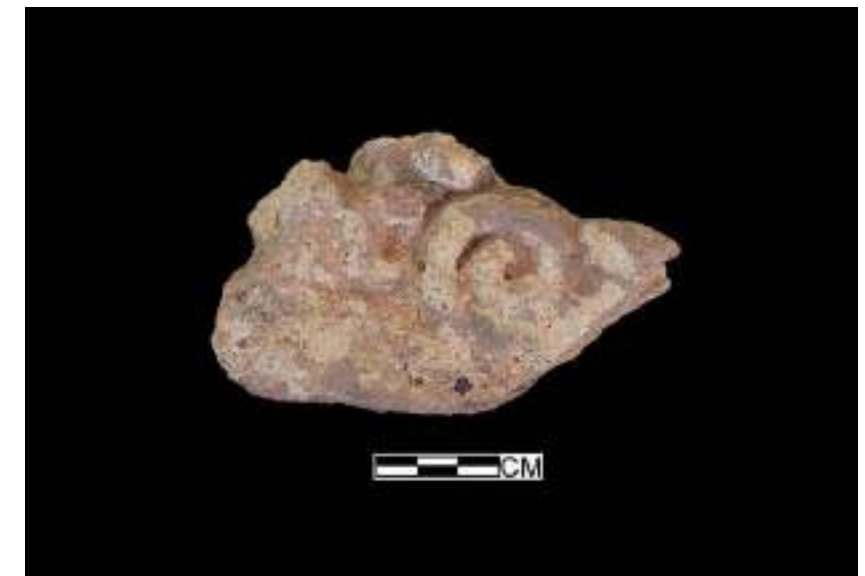
Tile pieces found while debris clearance

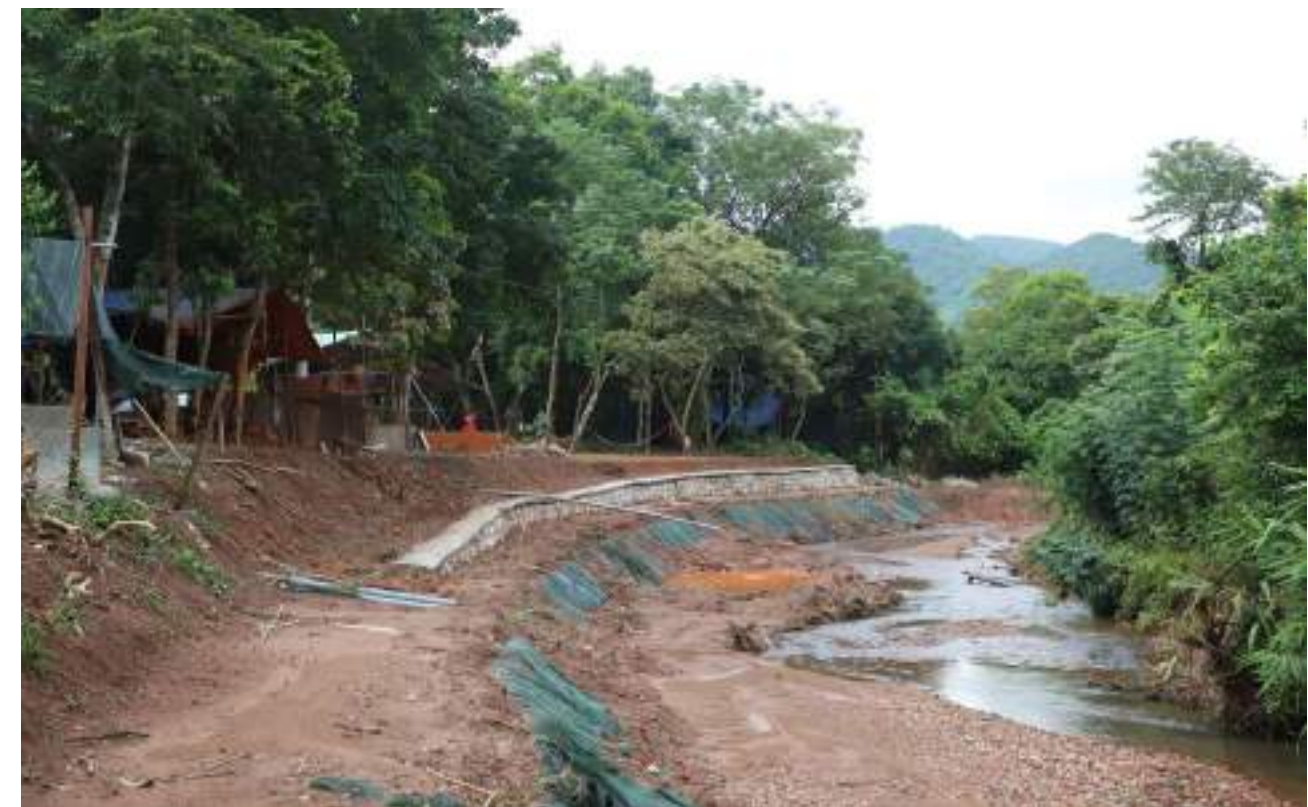
AFTER: East view of Bank protection wall

North of the F group of temples, the riverbank was washed out in the past. Currently, the outer enclosure wall is on the riverbank, which needs slope protection to avoid future flooding damage to the temple.

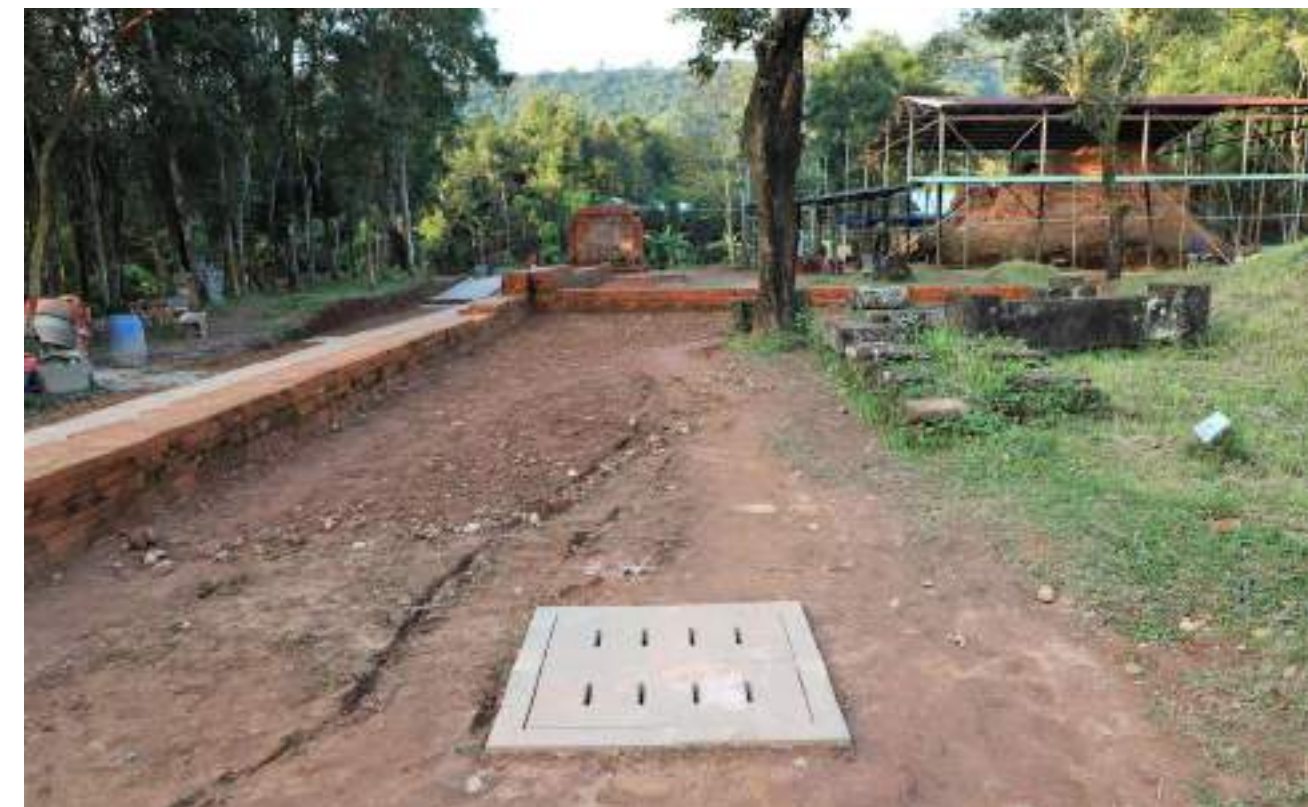
AFTER: Construction of Drain Chamber at south east

One of the major factors contributing to the deterioration of the temple foundations at the My Son complex is the stagnation of stormwater around the structures. Prolonged water accumulation accelerates foundation decay, promotes biological growth, and leads to soil instability beneath ancient masonry.

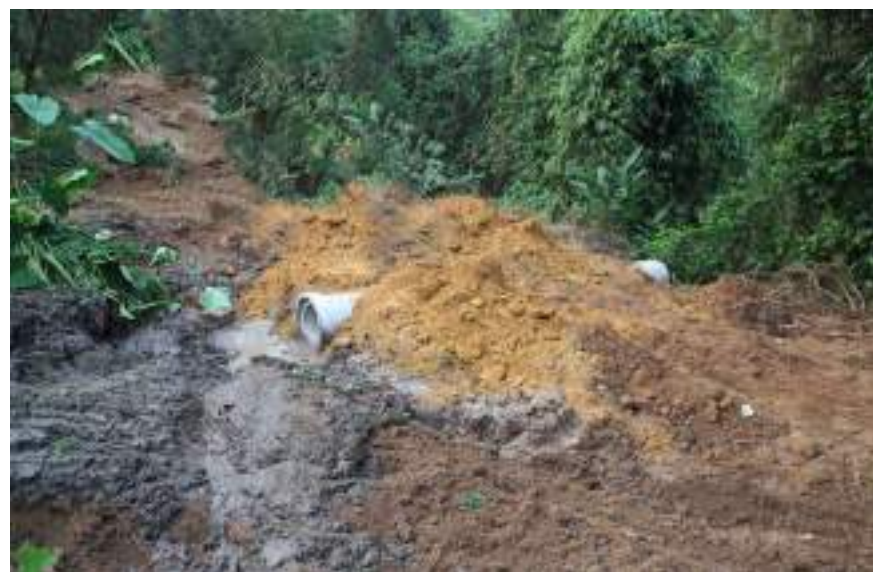
BEFORE: Construction of Causeway at Cham Hut

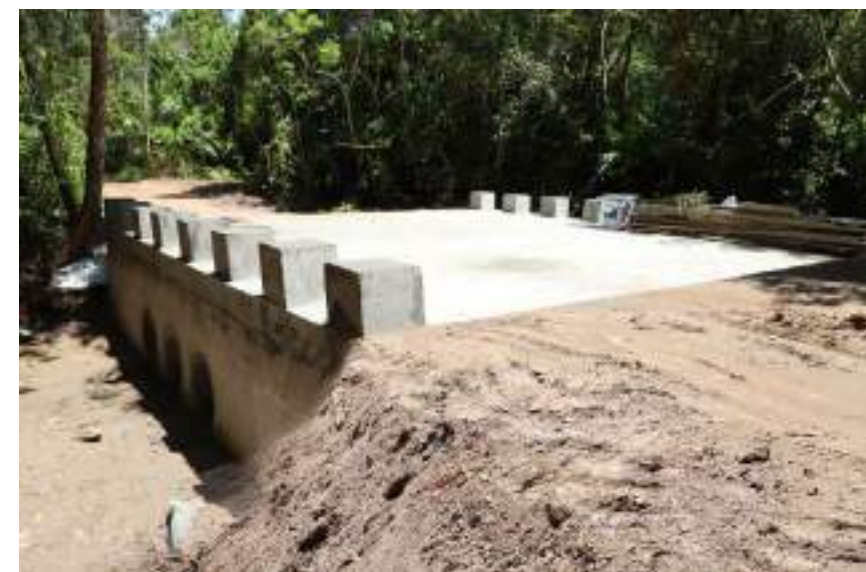
AFTER: Construction of Causeway at Cham Hut

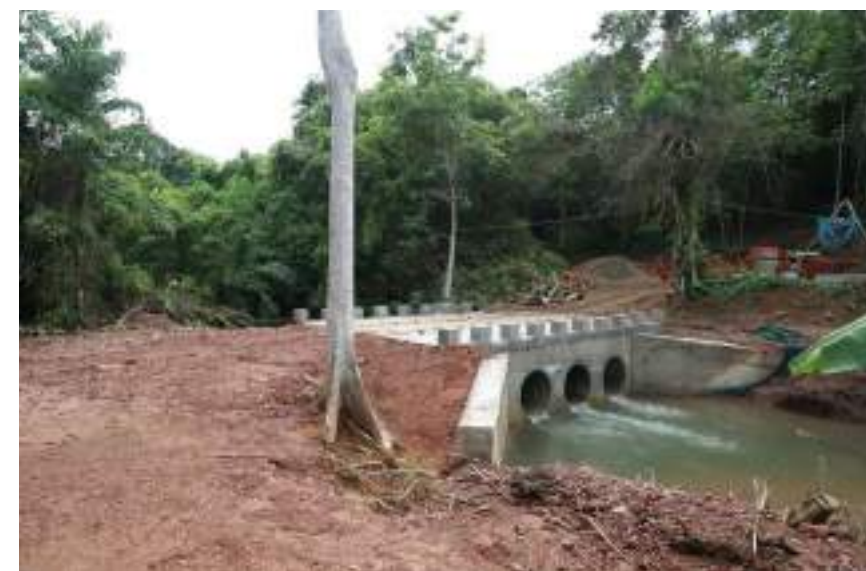
AFTER: Construction of Causeway at Group F temple

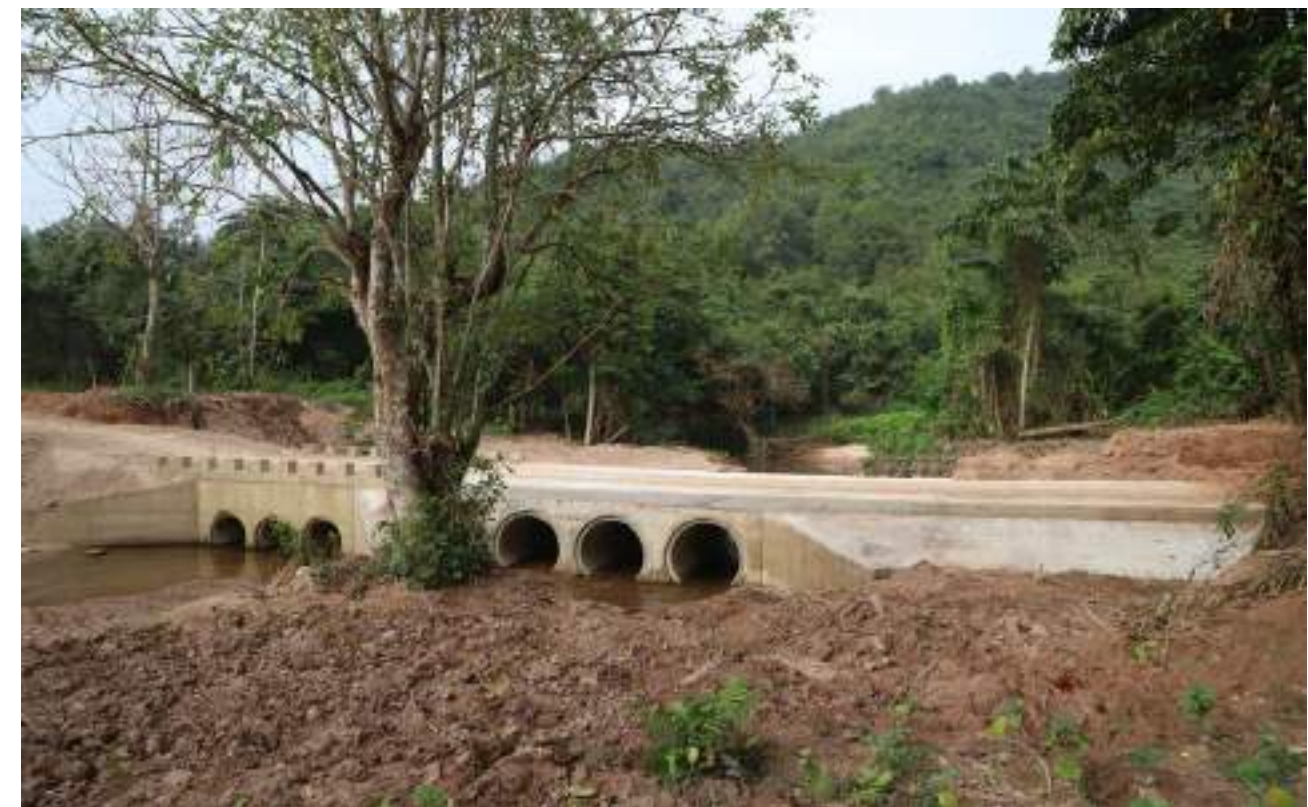
AFTER : Construction of Causeway at Group K

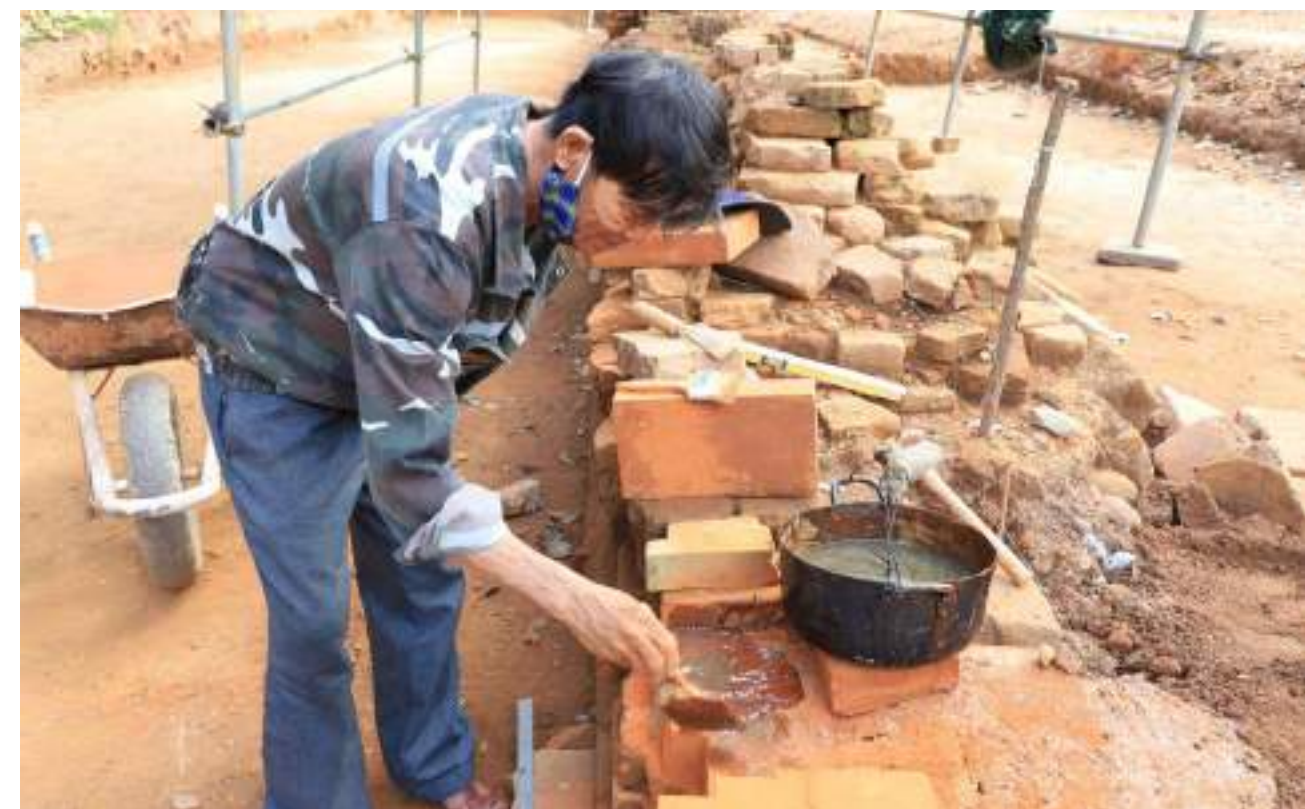
Resin Application

It has been a long-standing belief that the veneer brickwork was bonded using a locally available tree resin, botanically identified as *Dipterocarpus alatus*. To verify this, several brick samples collected from dislodged fragments at the site were examined by separating two adjoining layers. No visible traces of any resinous binder were observed. However, a fine layer of surkhi (brick dust powder) was noted between the brick surfaces.
